Case Study 1 and 1a

Getting the water quality right from a bore hole

Case Study 1a

Another variation of a bore hole water treatment system

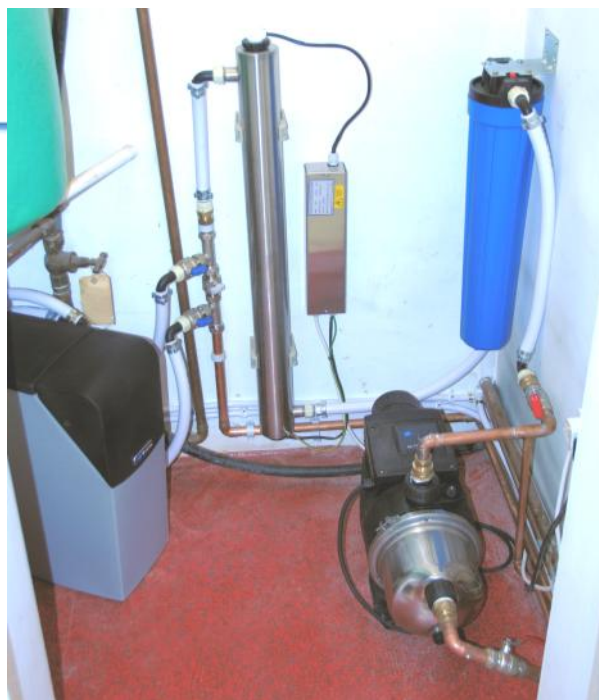
The completed installation. The pump is bolted to the floor. The filter is above it. The UV steriliser and electrics are mounted on the rear wall. The softener is shown on the left.

On the water treatment front it was decided to install an ultra violet steriliser, a water softener and a reverse osmosis (RO) drinking water system. Close to the incoming bore hole connection was a larder cupboard and this proved an ideal location in which to assemble most of the system.

After the pump a 20" filter housing was fitted with a 5 micron sediment filter. This protects the rest of the system from sediment and particulate contamination. It keeps the water clear so that the following ultra-violet (UV) steriliser (see Aquafacts No.18) can destroy most harmful micro-organisms. A UV system uses high intensity UV rays to constantly irradiate the water as it passes through an illuminated chamber.

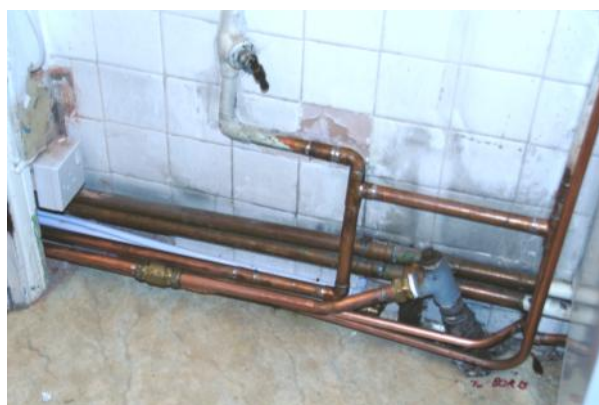
The plumbing above the bore hole (centre right) can be compared with the original set up in the photograph overleaf. The pipe work goes through the wall (left) into the larder cupboard.

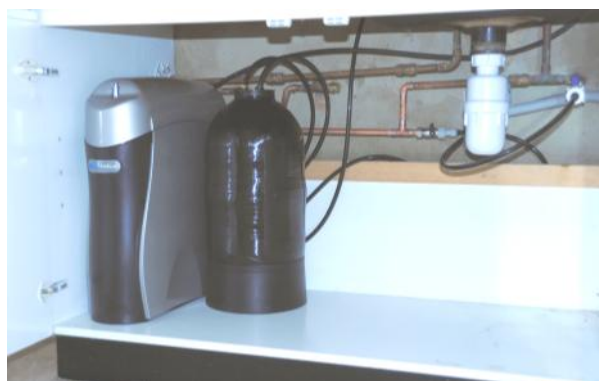
It was convenient to install the reverse osmosis drinking water system under the kitchen sink. New pipe work to the rear feeds bore hole water directly to an outside tap.

The RO system was installed under the kitchen sink. Although the UV provides volume water at a very high level of disinfection it is not 'fail safe' and therefore the RO, which can produce a 95 to 98% pure water regardless of incoming contamination, was an obvious choice. However, a domestic RO produces pure water slowly sufficient for drinking and cooking purposes only.

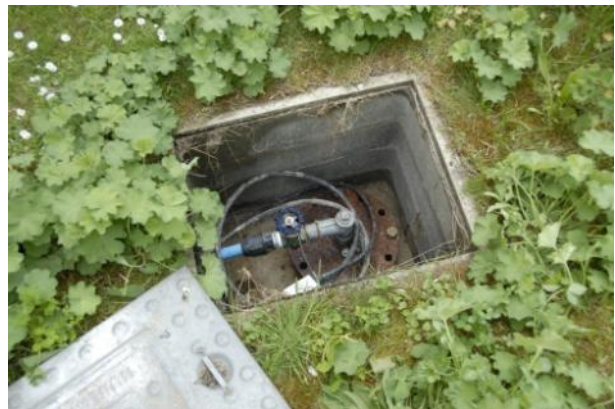
The bore hole (shown above) was sunk to a depth of 25 metres in 2004. It is sited about six metres from the main cottage wall. The 'Godwin' pump was found to be producing an excellent pressure of around 4 bar which was more than enough to provide a good continuous household pressure. As can be seen below the water supply is controlled, within the property, by a pressure sensing switch (coloured orange). The water then goes through a 5 micron sediment cartridge (blue), a 55 watt stainless steel UV system (mounted up the back wall) and then through an Aqua-twin water softener (sitting on the floor).

The bore hole was sunk only a few years before to replace an existing one (see top photograph). It was fitted with a submersible pump activated by a float switch operating with three loft tanks. All water, including drinking water, was supplied from these tanks. There was no water treatment protection and the condition of the tanks was far from hygienic.

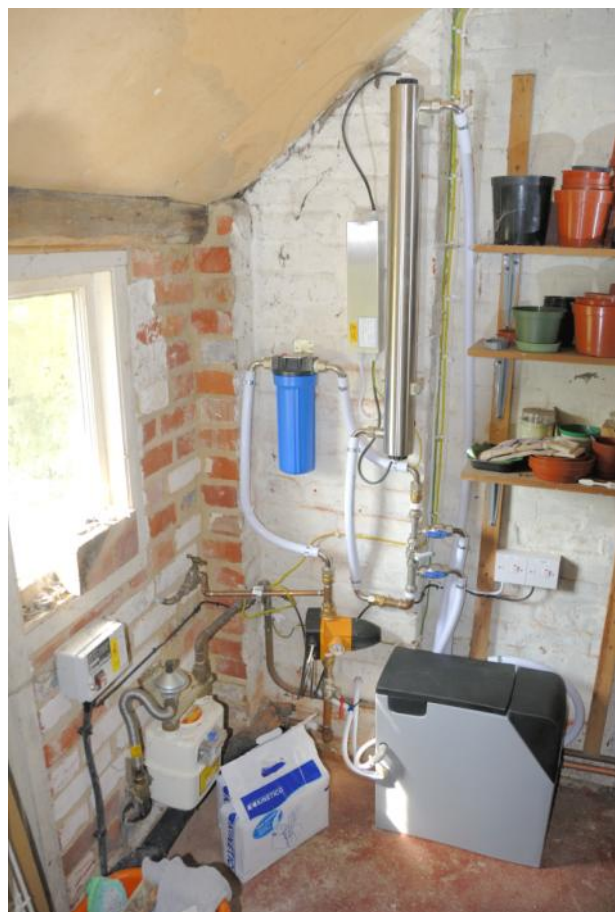
All the equipment we installed was located in a 'lean-to' on the side of the cottage where the supply pipe from the bore hole entered the property. As can be seen from the photograph (right) the pressure switch precedes the filter, softener and UV system (fitted in that order). A certain amount of new electric cable work was necessary to power the UV and pressure switch.

Besides installing a water softener, our recommendation, to kill off any ongoing organic contamination, was to fit a UV system with pre-filter. As with the previous case study we needed to provide constant water pressure, within the cottage, so that the water softener could operate. This involved disconnecting the float switch and replumbing the main loft tank with an ordinary input valve. An electric water pressure sensing switch was then connected to the pipe coming from the bore hole where the water supply entered the property. A secondary pump was unnecessary as the submersible pump was giving excellent above ground pressure of around 4 bar.
